EXTENSION & PLUGS FAB

SHDGC TRAILING CABLES REPAIR

MEGLAB'S MOULDED PLUGS AND EXTENSIONS FAB

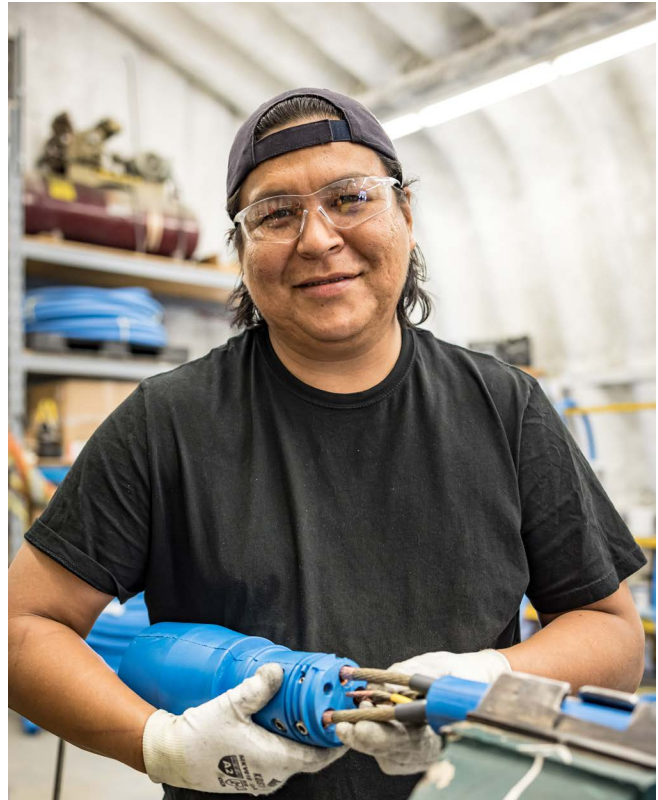
PROBLEMS	MEGLAB'S SOLUTION
Water penetration around the fasteners and the loss of flexibility of the cable	Meglab's moulded plug
Cuts to gloves and hands by metal clamps the use of electric tape only delays the problem	
The SHDGC cable is retained by the terminals

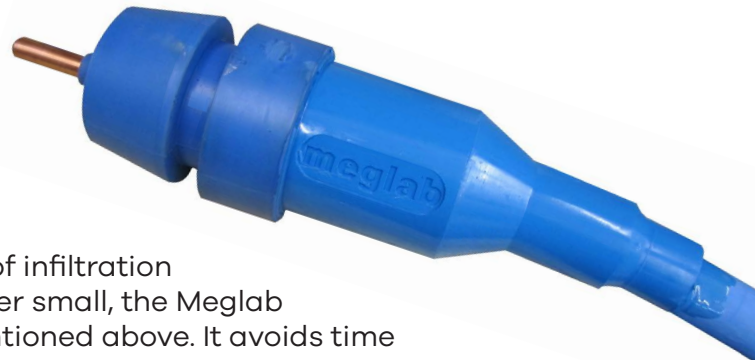
Up to 1000 volts

The moulded plug on the cables eliminate the risk of infiltration of water and short circuit. In addition, to being rather small, the Meglab moulded plug eliminates most of the problems mentioned above. It avoids time loss caused by incidents or water infiltration, which makes it an economic price.

- Eliminates the risk of water penetration
- Reduces the risk of injury
- Robust : solid cable plug connection
- Durable : less frequent repairs
